Delco Carburetor

BULLETIN 9D-201

SERVICE INFORMATION

New Screw Kit Released for Monojet Carburetors

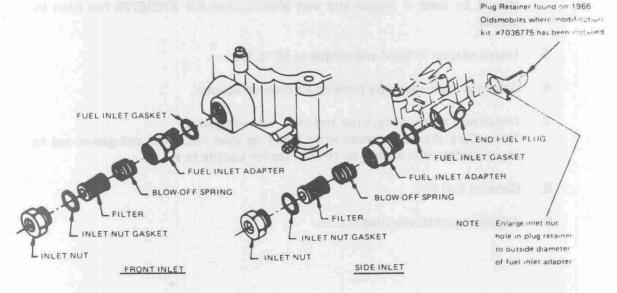
Two fuel inlet adapter repair kits are released to cover all Quadrajet models. Applications are as follows:

- 1. Remove fuel inlet nut, filter and spring and discard all parts.
- Blow out fuel inlet cavity in float bowl making sure it is free of chips and foreign material.
- 3. Apply Loctite Primer "T" to threaded area of bowl and on inlet nut adapter. Allow Primer "T" to dry on threads.

- 5. Install adapter in bowl and torque to 50 ft. lbs.
- 6. Blow out bowl cavity by blowing air through adapter.
- Install new filter spring, filter and inlet nut with gasket.
 Note: Care should be taken when installing inlet nut, filter and gasket not to move adapter as it takes 5 to 10 minutes for Loctite to set up.
- 8. Connect fuel line.
- Adjust engine to specified R.P.M.

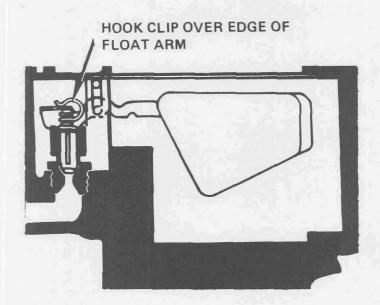
Reports have been received of incorrect installation of the float needle pull clip on the float arm during field replacement. If the clip is not installed as recommended, carburetor flooding can result.

It is reported that the end of the pull clip is being installed through the holes in the top of the float arm above the needle. These are locating holes used for manufacture of the float arm and are <u>not</u> to be used for the pull clip.

Correct installation of the float needle pull clip, is to hook the clip over the edge of the flat on float arm facing the float pontoon, as shown.

Note: The only exception to this is when using the float needle modification kit - Part Number 7036775. This needle pull clip hooks over the opposite edge of float arm as shown on instruction sheet in the kit.

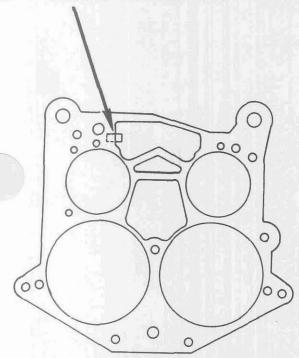
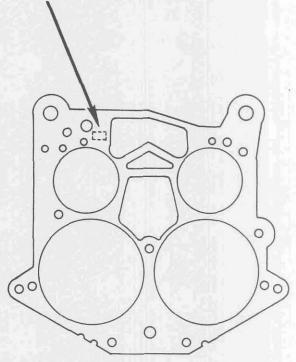
Field reports, along with returned samples, indicate servicemen sometimes are substituting the wrong throttle body to float bowl gasket on 1970 and later model Quadrajet carburetors. When this substitution is made, vacuum leaks occur causing rough idle due to air by-passing the primary throttle valves through the canister purge passage in the throttle body because the gasket will not seal this passage.

The difference between the throttle body to bowl gaskets is shown below:

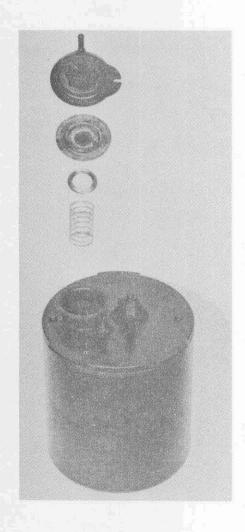
The purge valve located on the top of the fuel vapor collection canister, used on some applications, can be repaired without replacing the complete vapor canister. (See photo)

Service of the purge valve is not a routine maintenance item and should be performed if damaged or parts are missing.

Install parts in order shown in photo. Make sure spring is seated in metal retainer and diaphragm lays flat between purge valve flange on canister and diaphragm cover. Snap diaphragm cover in place aligning vacuum pick-up tube with vacuum hose.

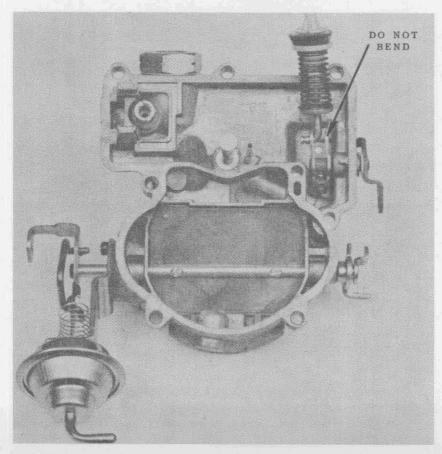
CAUTION: Do not remove pump plunger assembly by bending the retaining arm on inner lever. If bent, the retaining arm can cause binding, jamming and in some cases, allow the pump assembly to fall out of the lever.

When removing the pump plunger assembly from the inner pump lever on those models not using a retaining clip, it is necessary to first remove the inner pump lever from the pump shaft by loosening set screw on inner lever. Then remove inner pump lever from pump shaft. Rotate pump plunger assembly until upper end of plunger rod slips out of hole in inner pump lever.

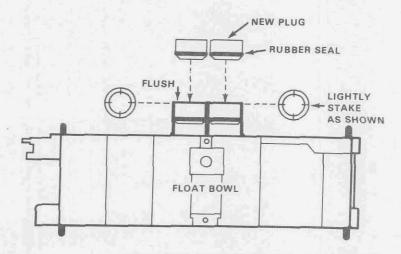
INSTALLATION
SECONDARY MAIN WELL PLUGS

The secondary main well plug repair kit is released for use on early model carburetors which use the brass cup plug or solid aluminum plug without spinning. This kit should not be used on later models with the "spun-in" type secondary main well plug.

- 1. Disassemble carburetor.
- 2. Place float bowl on stand and fill half full of fuel.
- 3. Observe plug area for fuel seepage.
- 4. In plugs leak, remove early type brass cup plugs with "Easy-out". If plug is solid type (without spinning), use a 3/16" stop drill and drill hole 1/4" deep in center of old plug. Use "Easy-out" and remove plug.

CAUTION: Do not drill through plug as casting may be damaged in well area. Blow out casting to remove dirt and chips.

5. Install rubber "0" ring seal into groove in new plug. Lube assembly with light engine oil, then carefully drive plug into main well, chamfered end down. Top of plug should be flush with casting. Lightly stake in place.
